# PRESIDENTIAL COMMISSION

*on the Space Shuttle  
Challenger Accident*

Presidential Commission  
on the  
Space Shuttle Challenger Accident

June 6, 1986

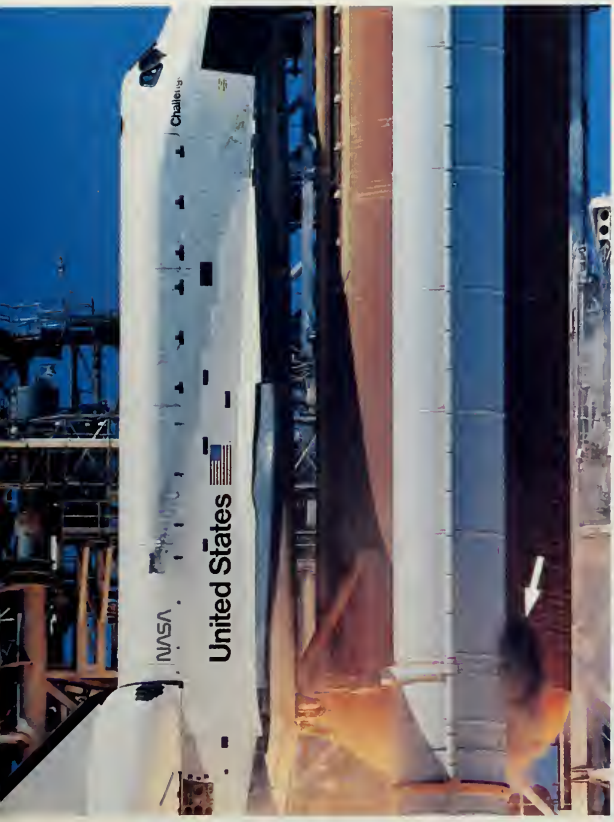
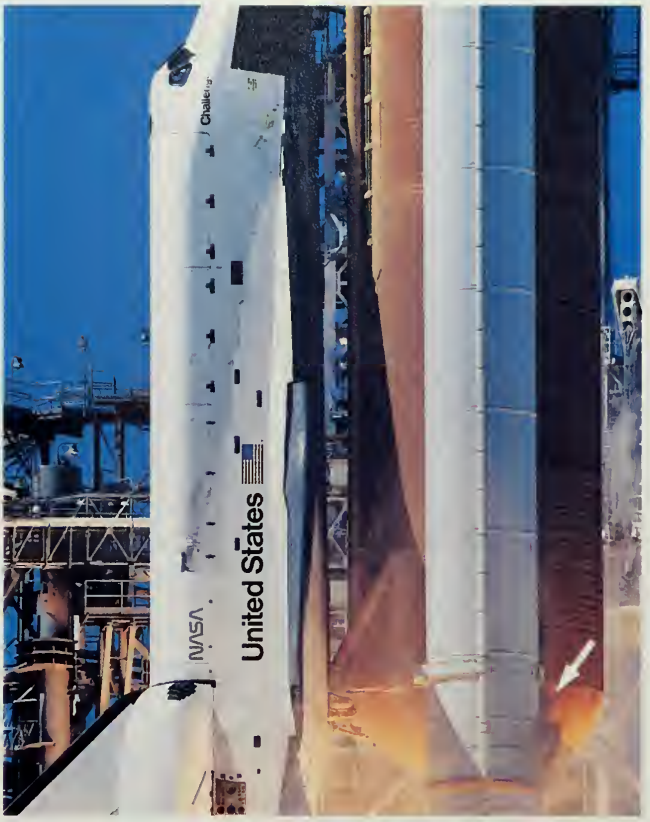
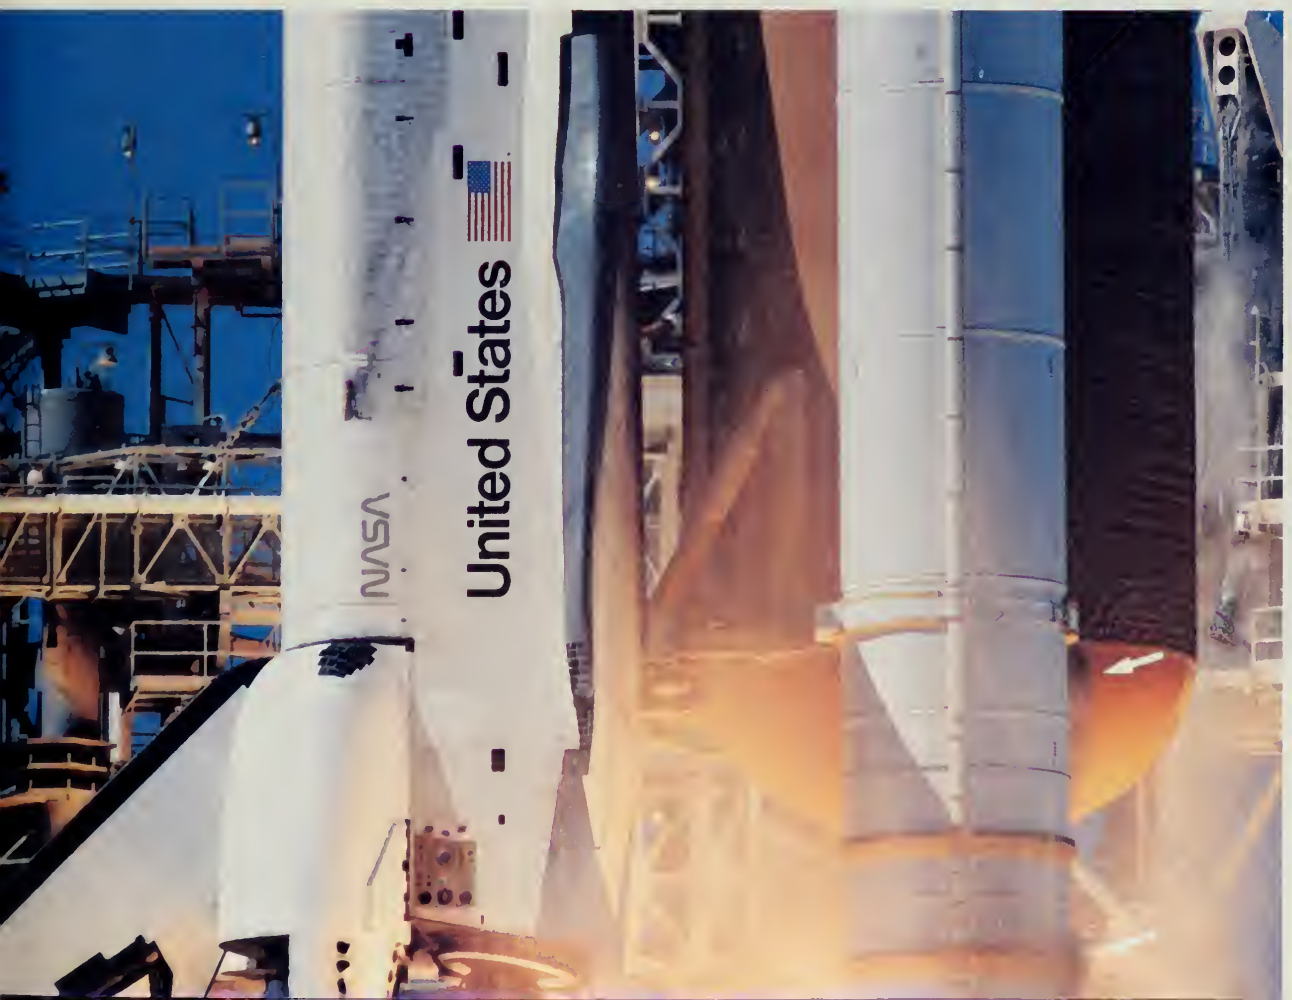
Immediately after solid rocket motor ignition, dark smoke (arrows) swirled out between the right hand booster and the External Tank. The smoke's origin, behavior and duration was approximated by visual analysis and computer enhancement of film from five camera locations. Consensus: smoke was first discernible at .678 seconds Mission Elapsed Time in the vicinity of the right booster's aft field joint.

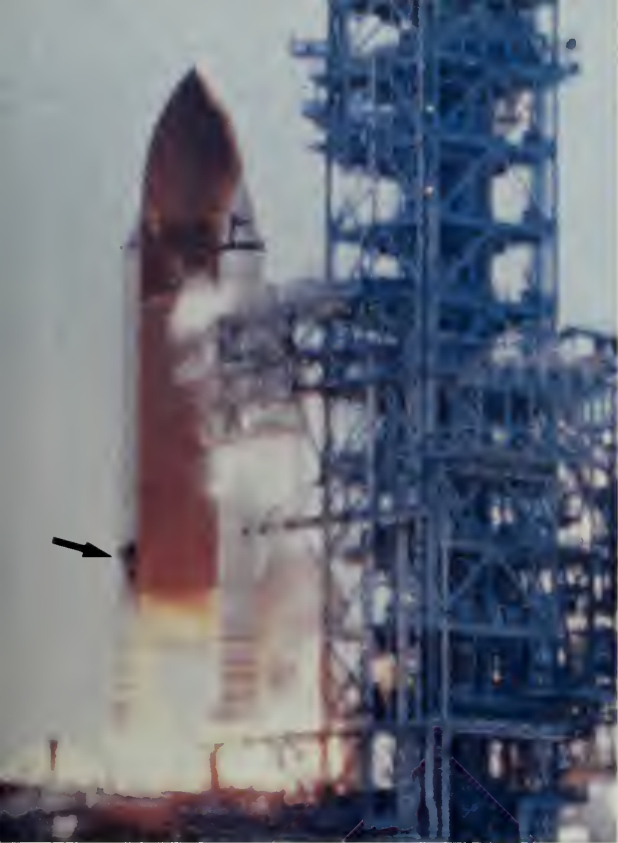
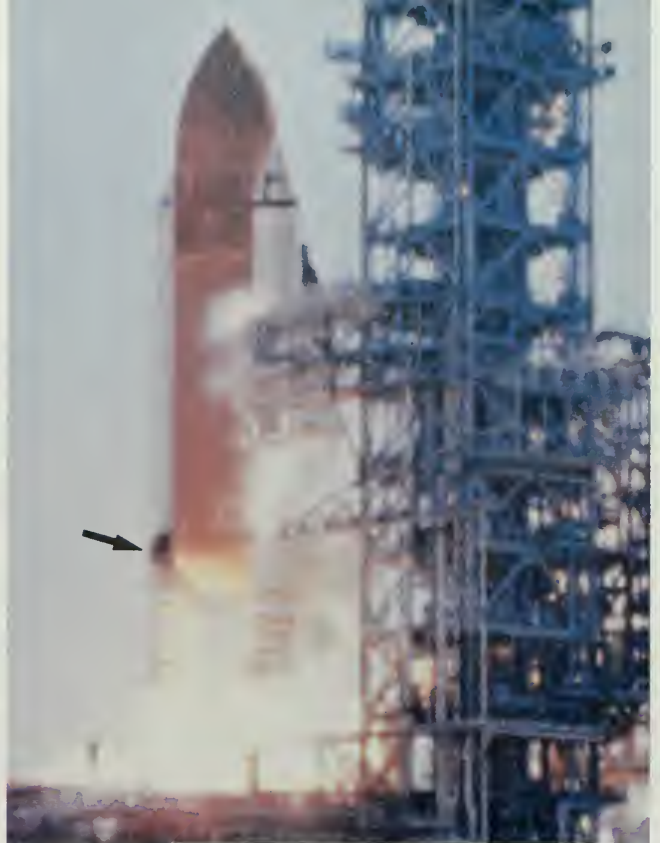
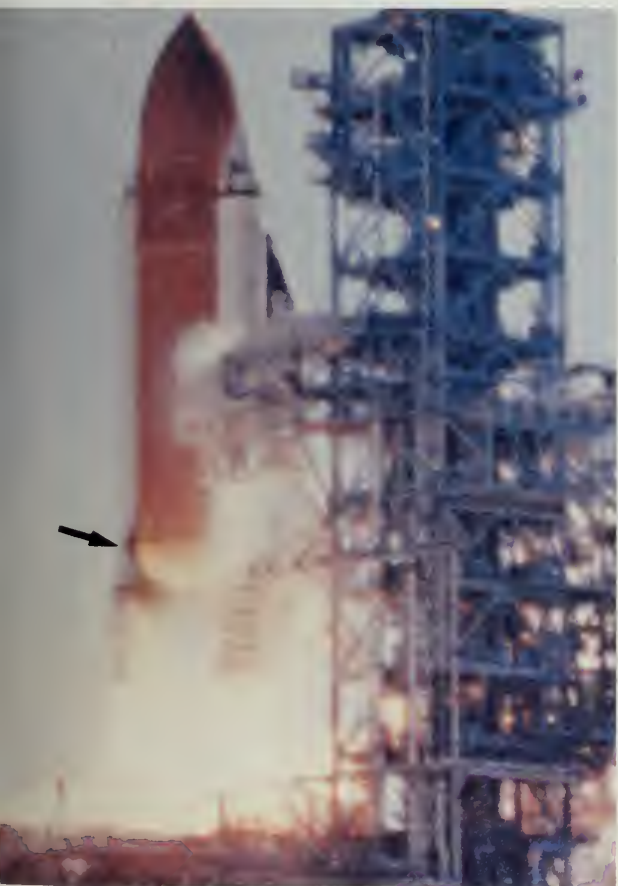
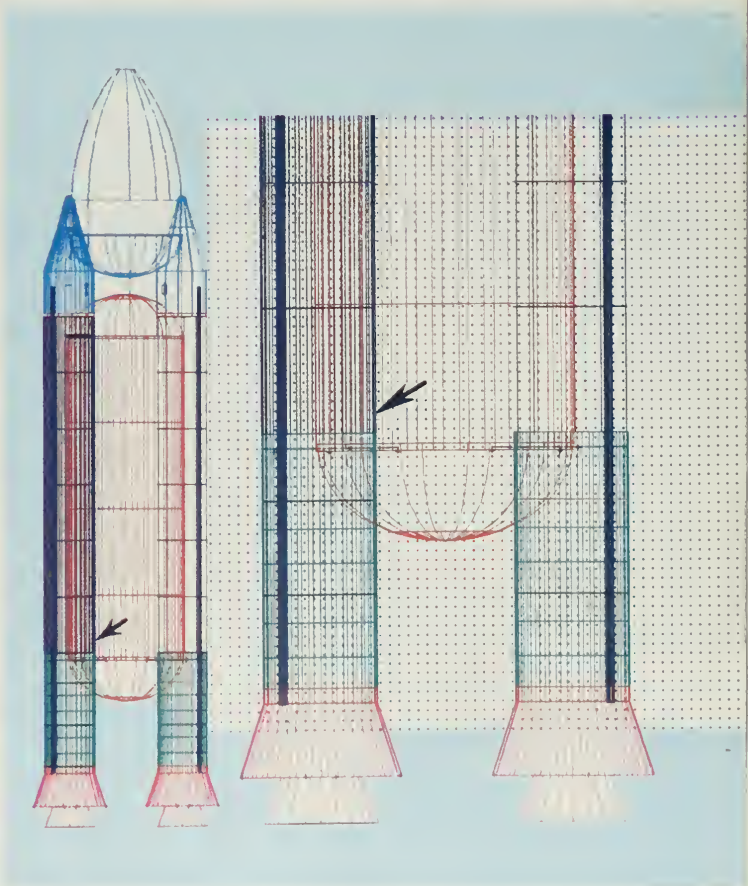
Multiple smoke puffs are visible in the photo above (arrows). They began at .836 seconds and continued through 2.500 seconds, occurring about 4 times a second. Upward motion of the vehicle caused the smoke to drift downward and blur into a single cloud. Smoke source is shown in the computer generated drawing (far right).

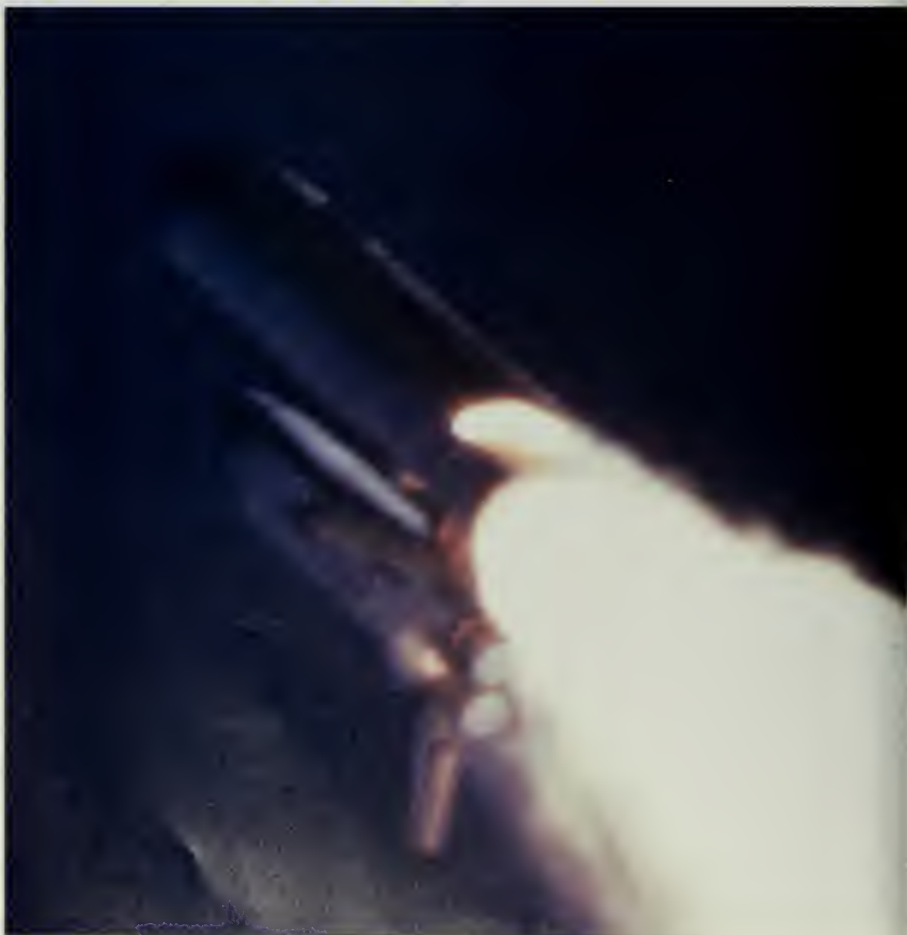
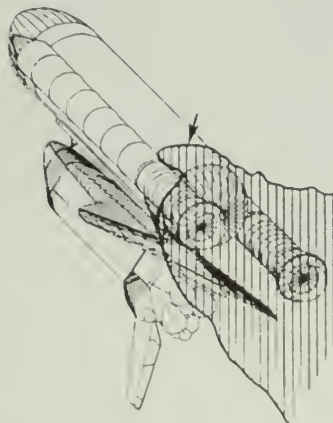
At 58.788 seconds, the first flicker of flame appeared. Barely visible above, it grew into a large plume and began to impinge on the External Tank at about 60 seconds. Flame is pinpointed in the computer drawing between the right booster and the tank, as in the case of earlier smoke puffs. At far right (arrow), vapor is seen escaping from the apparently breached External Tank.

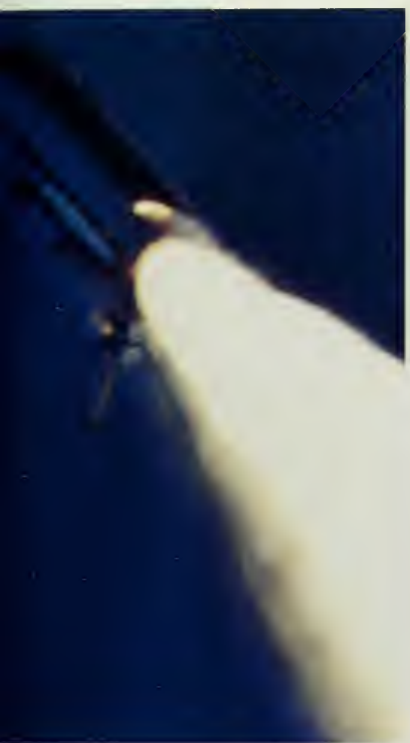
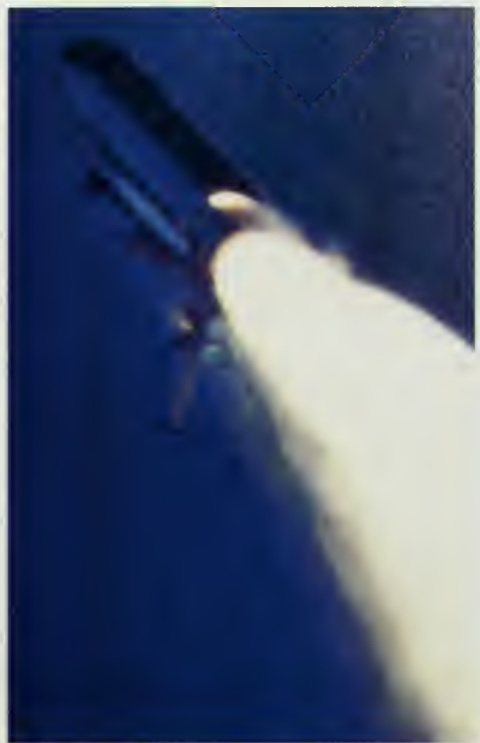
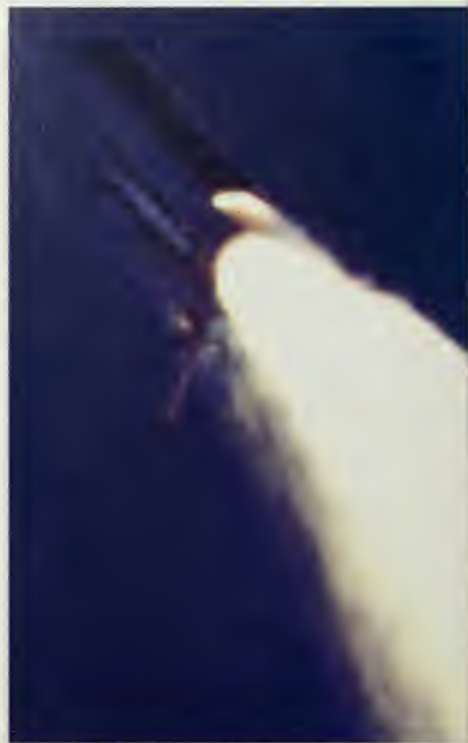
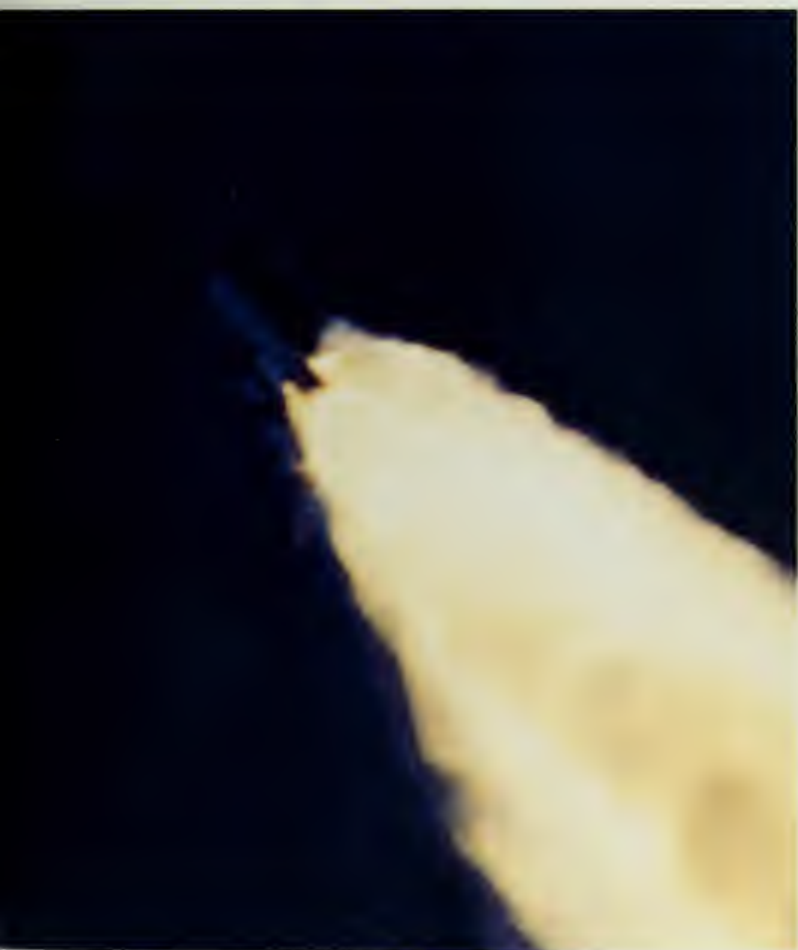
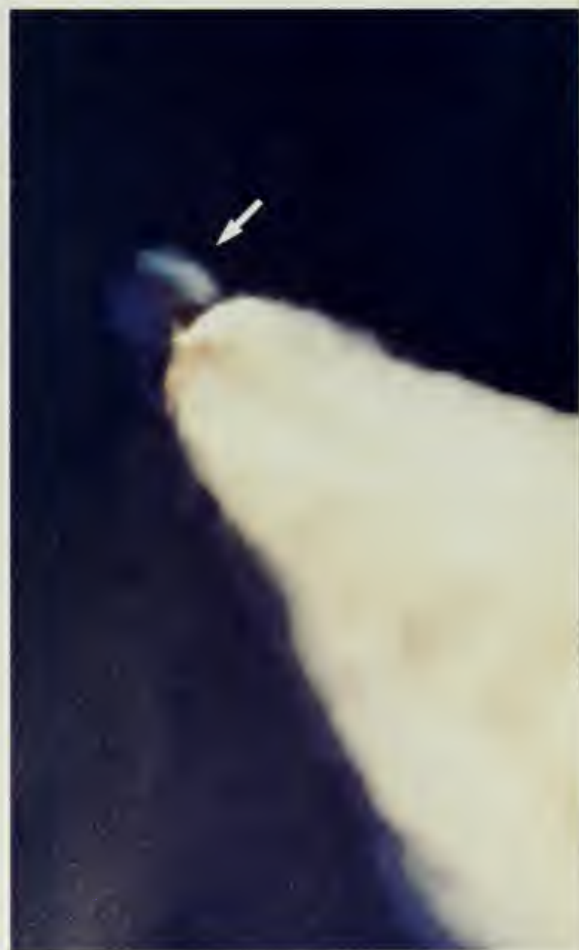
Camera views indicate the beginning of rupture of the liquid hydrogen and liquid oxygen tanks within the External Tank. A small flash (arrows above) intensified rapidly, then diminished. A second flash,

attributed to rupture of the liquid oxygen tank, occurred above the booster/tank forward attachment (below left) and grew in milliseconds to the maximum size indicated in the computer drawing.

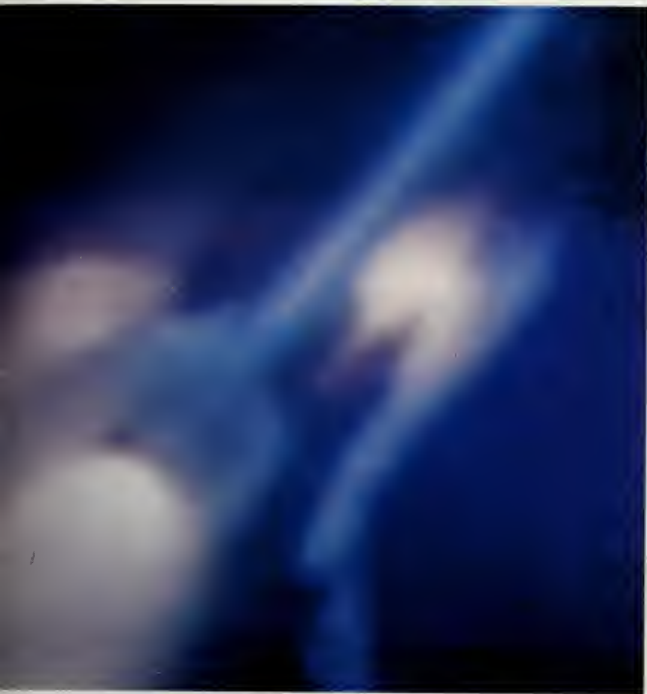
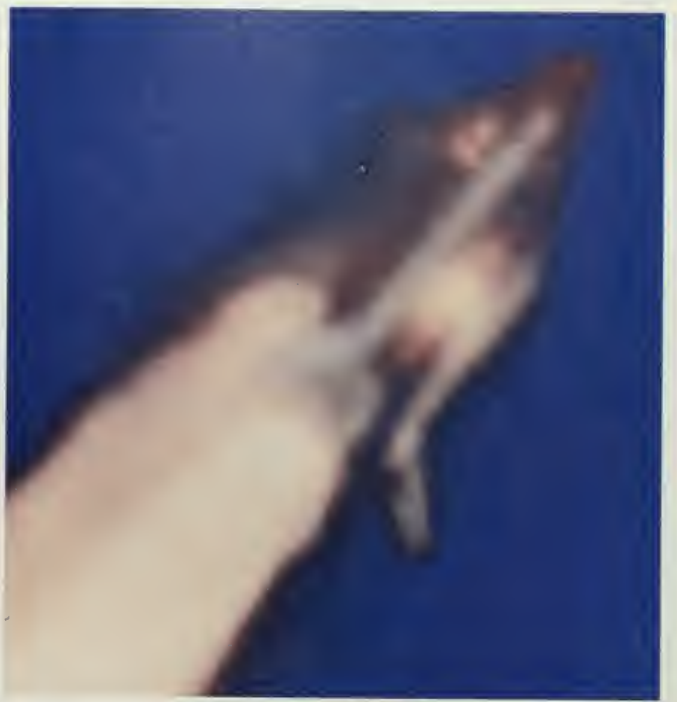
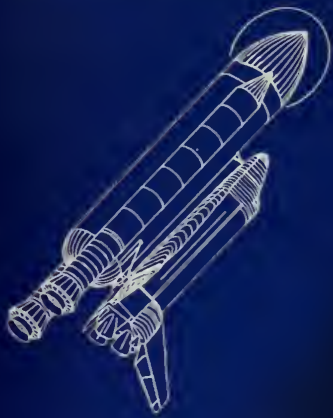
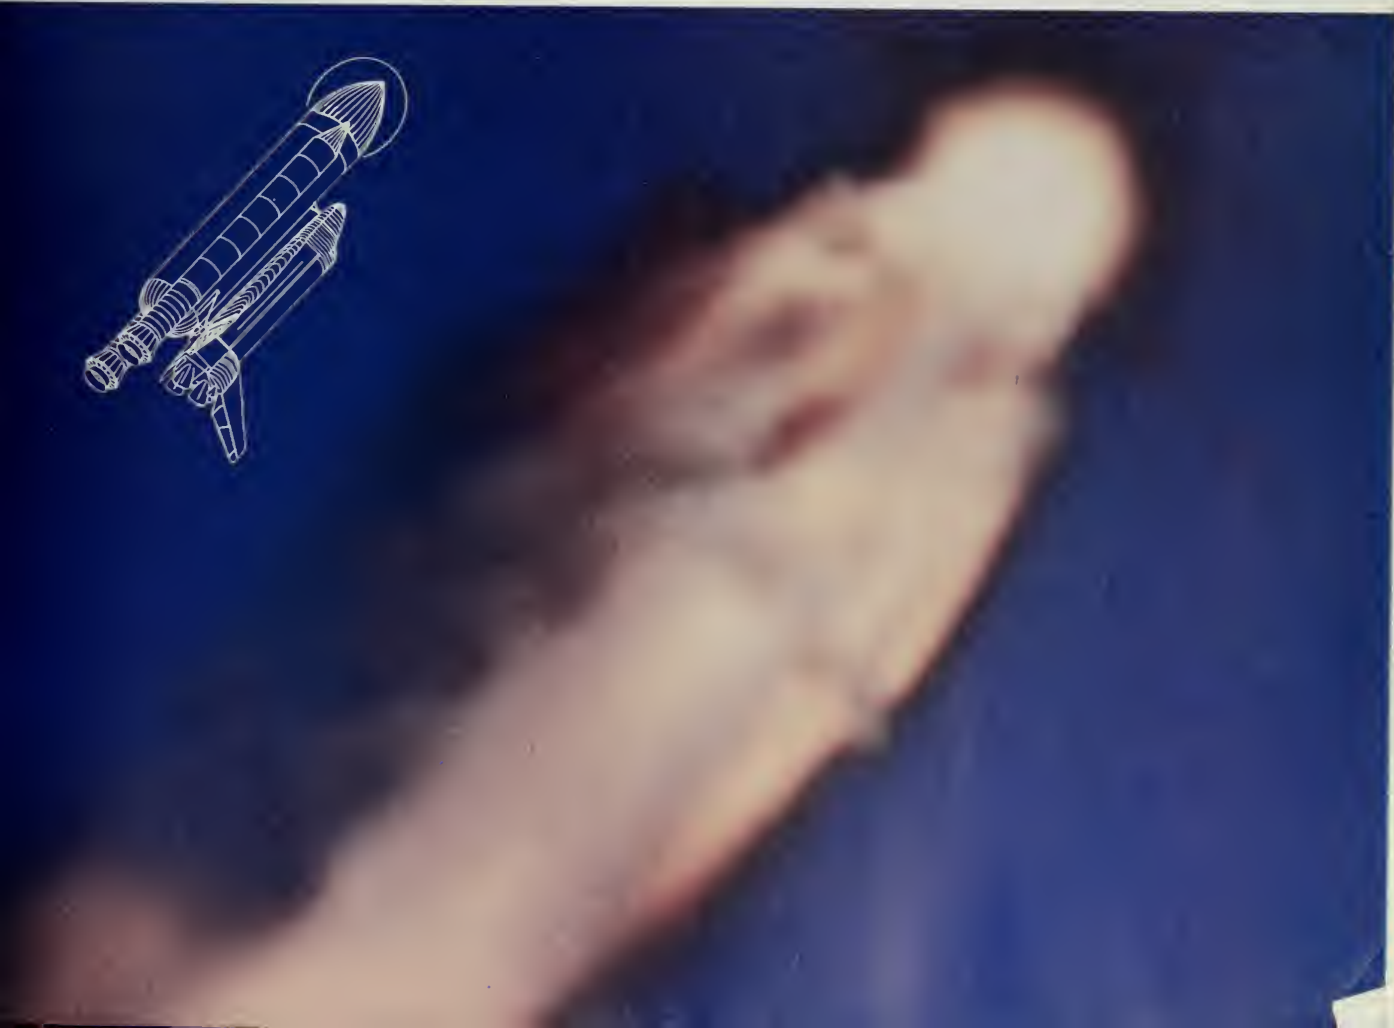
Structural breakup of the vehicle began at approximately 73 seconds. Fire spread very rapidly. Above, a bright flash (arrow) is evident near the nose of the Orbiter, suggesting spillage and ignition of the spacecraft's reaction control system propellants. At left, the two Solid Rocket Boosters thrust away from the fire, crisscrossing to form a "V." The right booster—identifiable by its failure plume—now to the left of its counterpart. At right, the External Tank wreckage is obscured by smoke and vapor. The Orbiter engines still firing, is visible at bottom center.

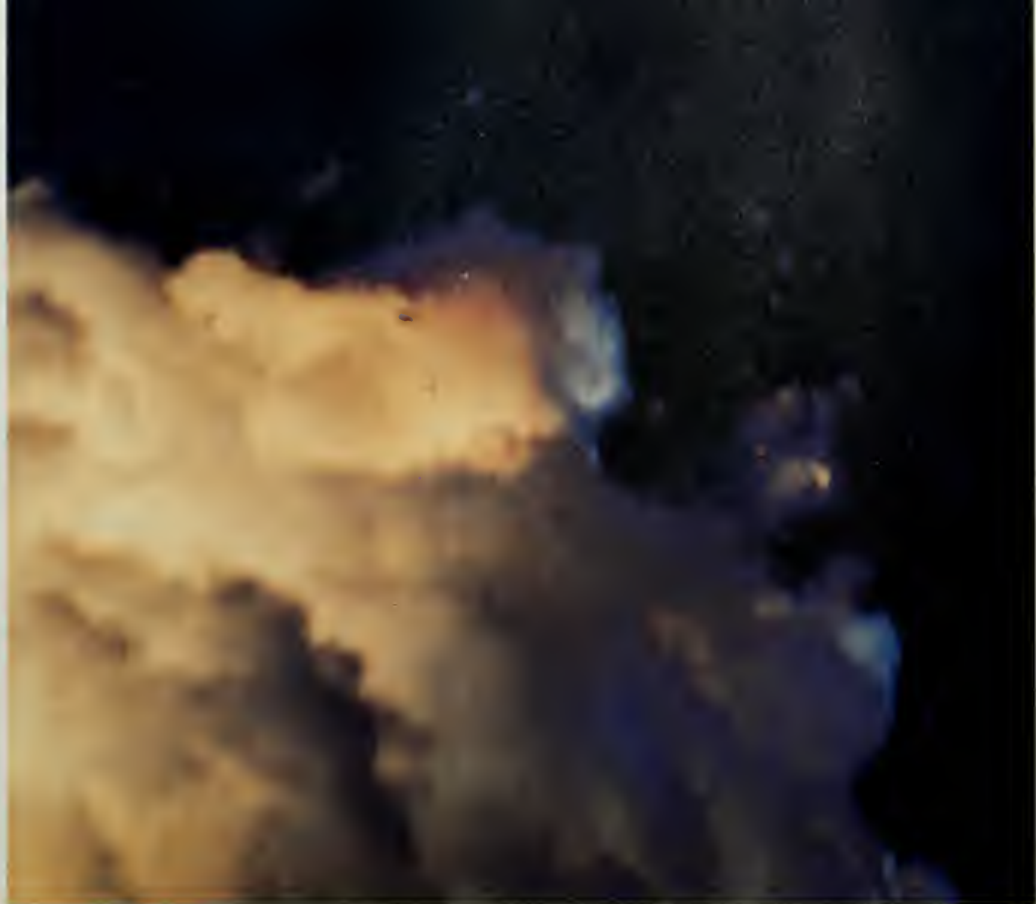
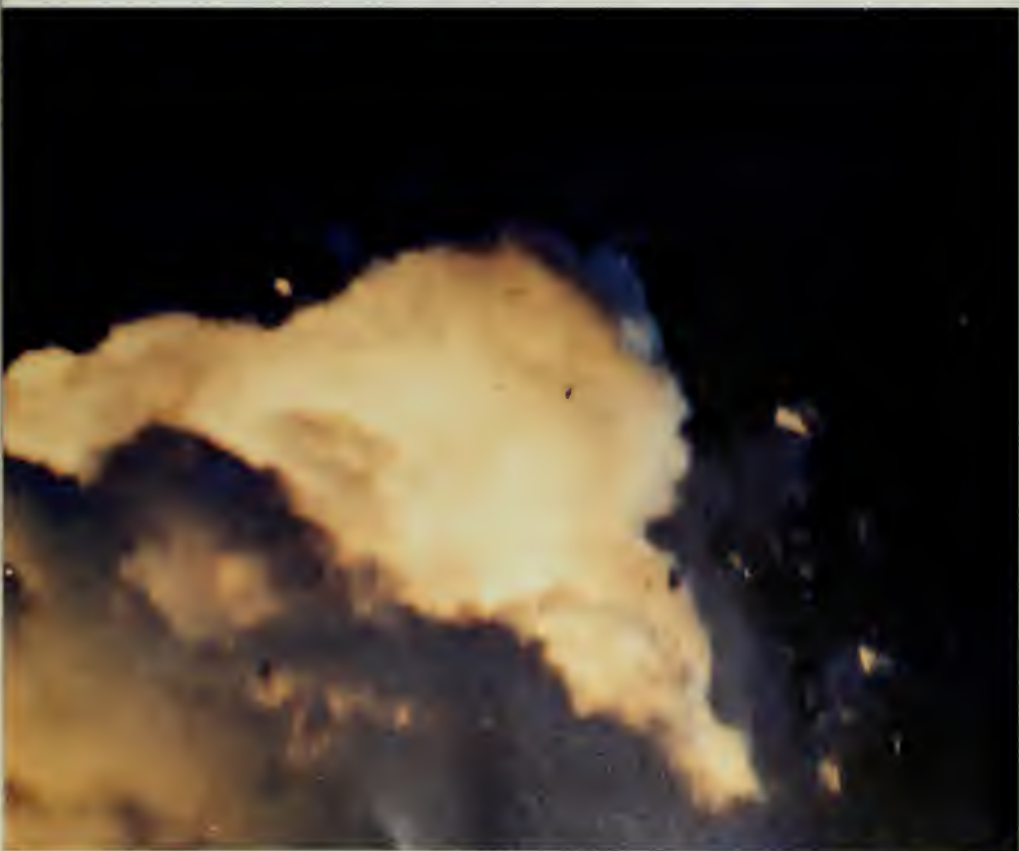
At about 76 seconds, unidentifiable fragments of the Shuttle vehicle can be seen tumbling against a background of fire, smoke and vaporized propellants from the External Tank (left). In the photo at right, the left booster (far right)

soars away, still thrusting. The reddish-brown cloud envelops the disintegrating Orbiter. The color is characteristic of the nitrogen tetroxide oxidizer in the Orbiter Reaction Control System propellant.

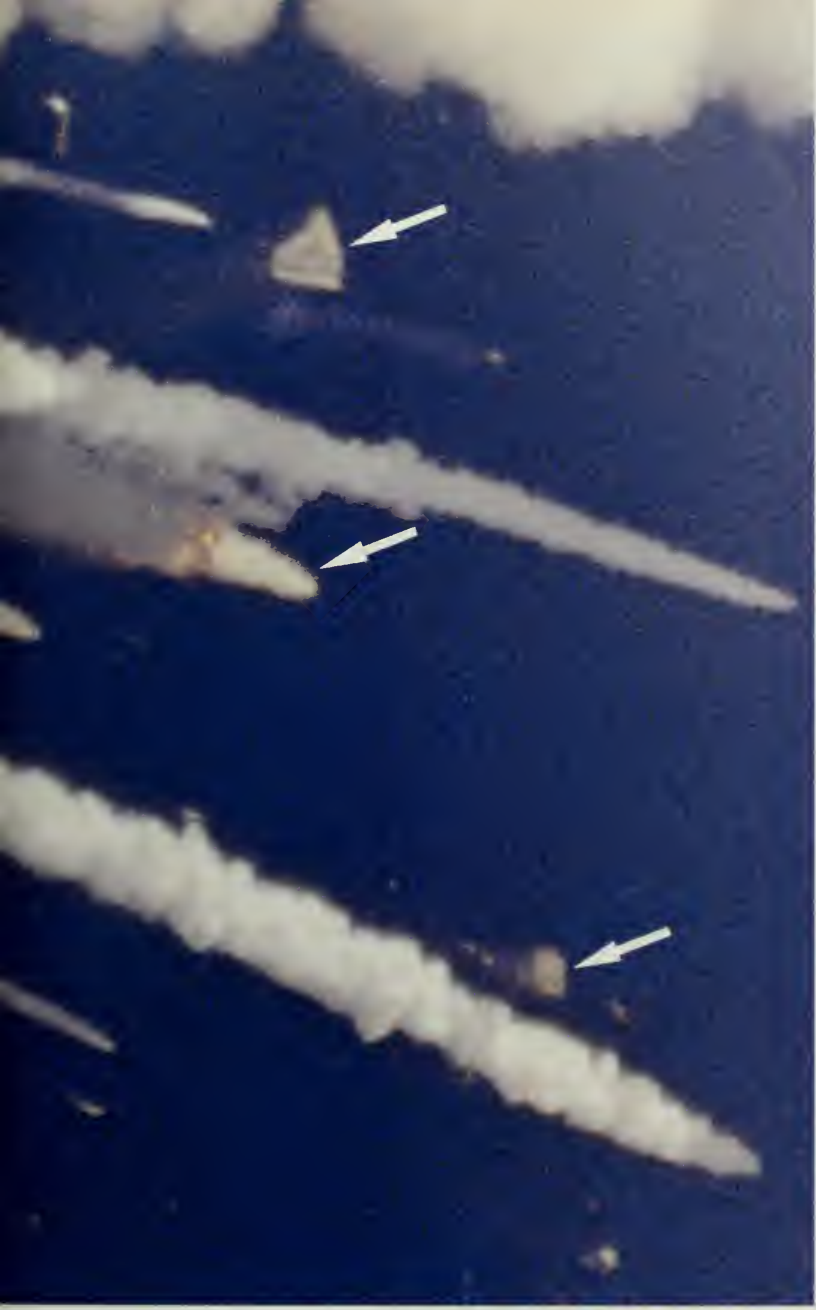
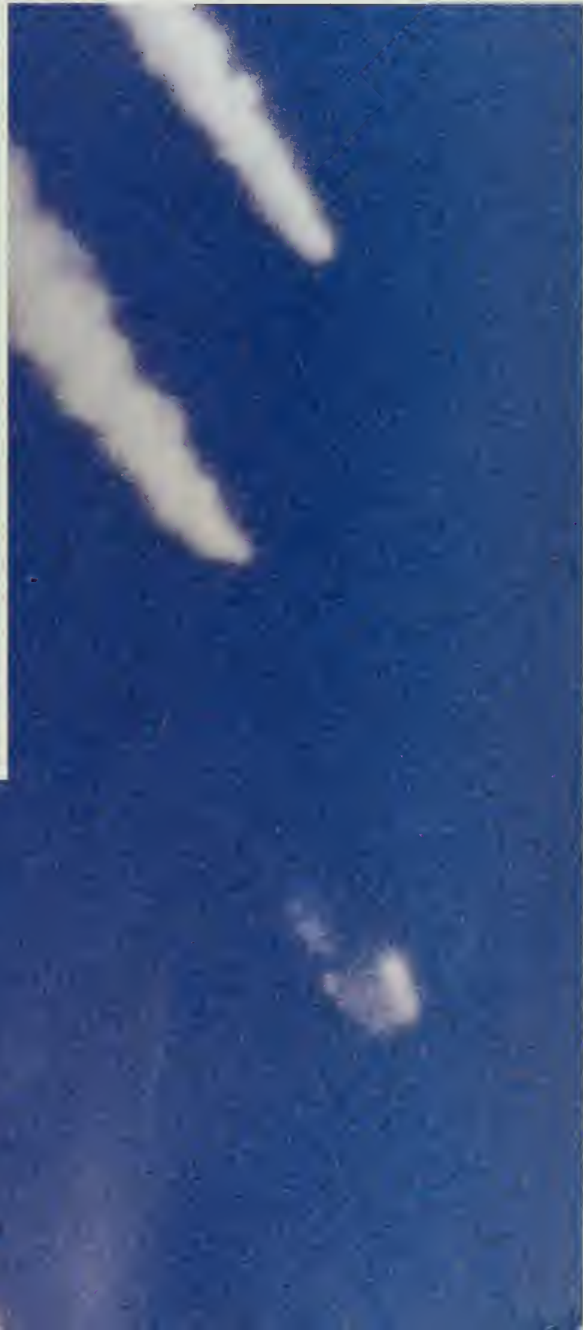
Hurling out of the fireball at 78 seconds (left) are the Orbiter's left wing (top arrow), the main engines (center arrow) and the forward fuselage (bottom arrow). In the photo below, it plunges Earthward, trailed by smoking fragments of Challenger.

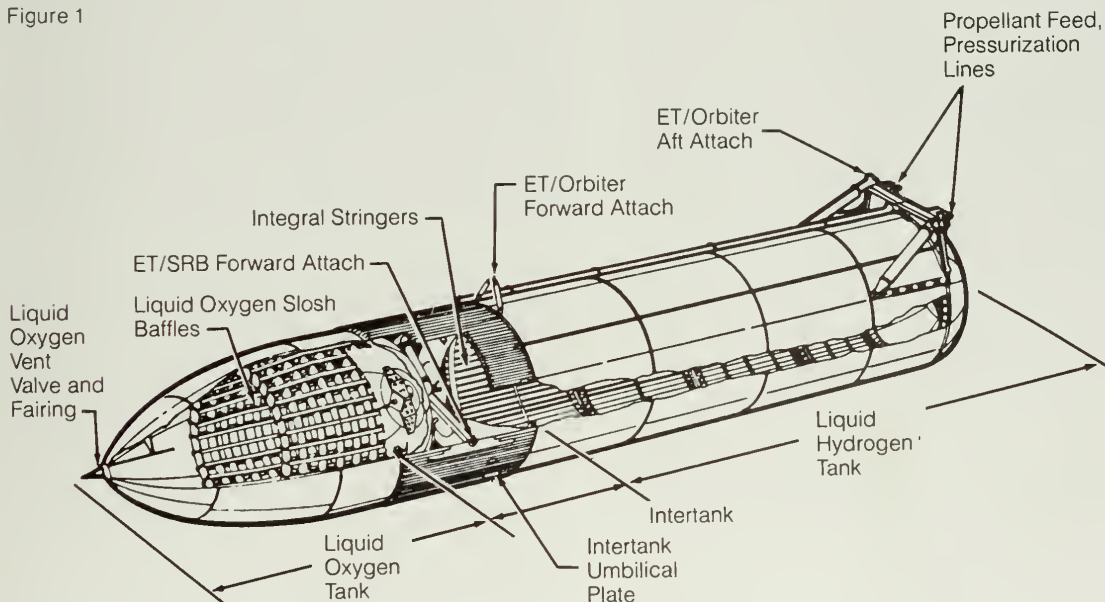
Figure 1

The possibility of an imperfection existing in either the pressurized or nonpressurized External Tank structural elements that could grow to a sufficient size to cause structural failure was examined in detail. All construction history, structural qualification test data, proof test inspection records and x-rays were reviewed. One previously

undetected imperfection that was discovered during a reexamination of the x-rays was found in recovered hardware with no propagation indicated.<sup>3</sup> Other data from the pre-launch ice and frost team inspections, film and video coverage, pressurization records and flight data revealed no evidence of leakage. The Commission concluded that no structural imperfections existed that could have grown to a size to create a leak or cause catastrophic failure of the External Tank.

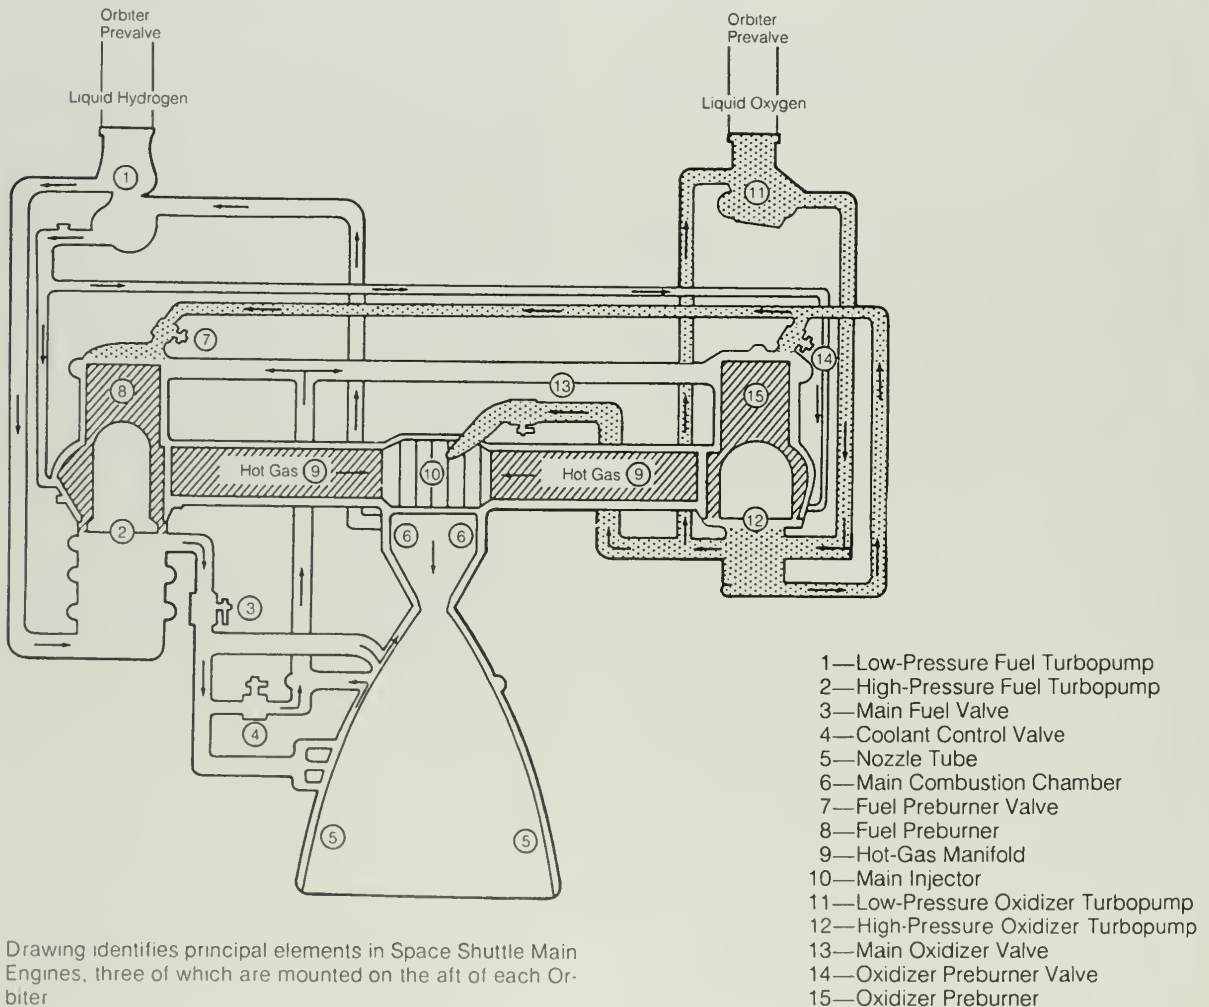
Figure 4

The first abnormal engine indication was a drop in engine fuel tank pressure at 72.564 seconds. As fuel pressure dropped, the control system automatically responded by opening the fuel flowrate valve. The turbine temperatures then increased because of the leaner fuel mixture.

The increased temperature caused an increase in pump speed. This could not, however, increase the fuel pressure because of a decrease in fuel tank top (ullage) pressure resulting from the burned through hydrogen tank leakage. When the fuel pump pressures dropped below 140 pounds per square inch, the programed control system disqualified the measured data because it was past reasonable limits. This caused the fuel flowrate and high-pressure fuel pump discharge pressure to decrease, while the lack of load allowed the pump's speed to increase. The decreased fuel flow caused a drop in fuel preburner chamber pressure, though the fuel preburner oxygen valve was then advancing toward a more open position. The mixture ratio in the fuel preburner became leaner, which raised high-pressure fuel turbine discharge temperatures above the redline limits. This caused the engine control system to start automatic shutdown of the engine.

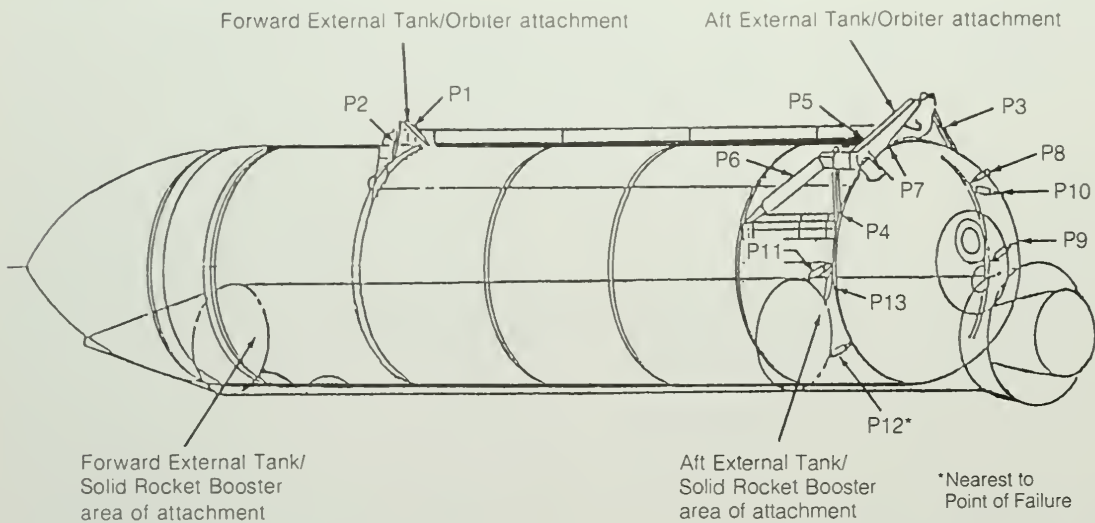
Figure 10  
Drawing of transparent External Tank, with right Solid Rocket Booster on far side, shows location of struts measured in table of strut loads. (Figure 9)

The STS 51-L lift off loads were compared to design loads and flight measured loads for STS-1 through STS-7 (Figure 9). The Shuttle strut identification is shown in Figure 10. The loads measured on the struts are good indicators of stress since all loads between Shuttle elements are carried through the struts. The STS 51-L lift off loads were within the design limit.

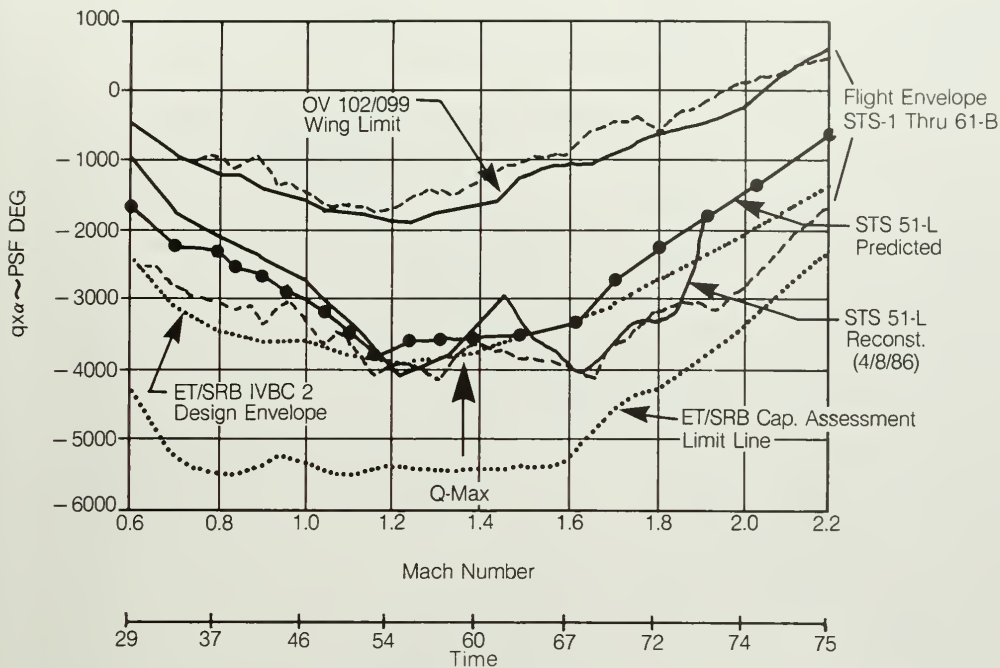
The Solid Rocket Motor field joint axial tension loads were substantially lower at maximum dynamic pressure than at lift off:  $11.6 \times 10^6$  pounds for the forward field joint and  $10.6 \times 10^6$  pounds for the aft field joint. Compared to the internal pressure loads, the dynamic variations due to wind shear were small—about  $1/15$  those of the pressure loads. *These loads were well below the design limit loads and were not considered the cause of the accident.*

Figure 11  
The loads in the pitch plane are shown by the solid line marked "STS 51-L RECONST." The curve "STS 51-L PREDICTED" give the loads expected before the flight. The dashed lines show the limit of experience from STS-1 through 61-B. The present design limits are the two lines marked "OV

102/099 WING LIMIT" above, and "ET/SRB CAP. ASSESSMENT LIMIT LINE" below. (After STS-6, the wing was strengthened. The previous design limits were "ET/SRB IVBC 2 DESIGN ENVELOPE" below, and a curve in the positive region of  $q \times \alpha$  above)

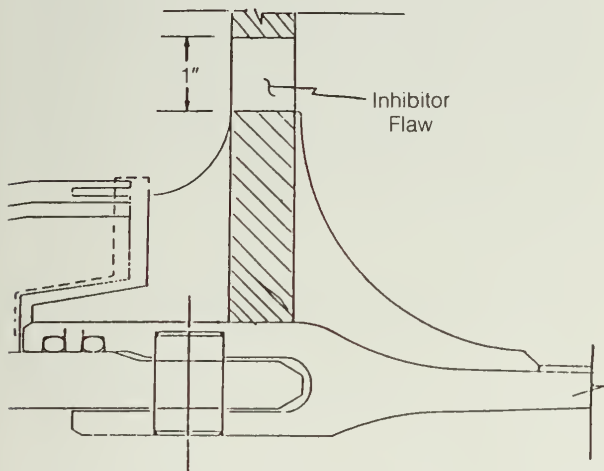
Figure 12  
Sketch shows location of assumed inhibitor flaw used in eliminating such a problem as a possible cause.

Evaluation of potential insulation or inhibitor (see Figure 12) flaws against the three criteria above resulted in elimination of all candidates except a defect in the forward-facing inhibitor. This potential failure mode was evaluated by assuming a 1-inch-diameter hole in the inhibitor. Analysis indicated that the change in motor internal pressure resulting from this failure would probably not be detected. However, an erosion rate substantially higher than the observed values would be required to burn through the membrane by 58 seconds. In addition, the assumed flaw is unlikely since the inhibitor is constructed by vulcanizing eight individual plies of the material. Subsequent damage of the magnitude required is improbable and would be easily detected.

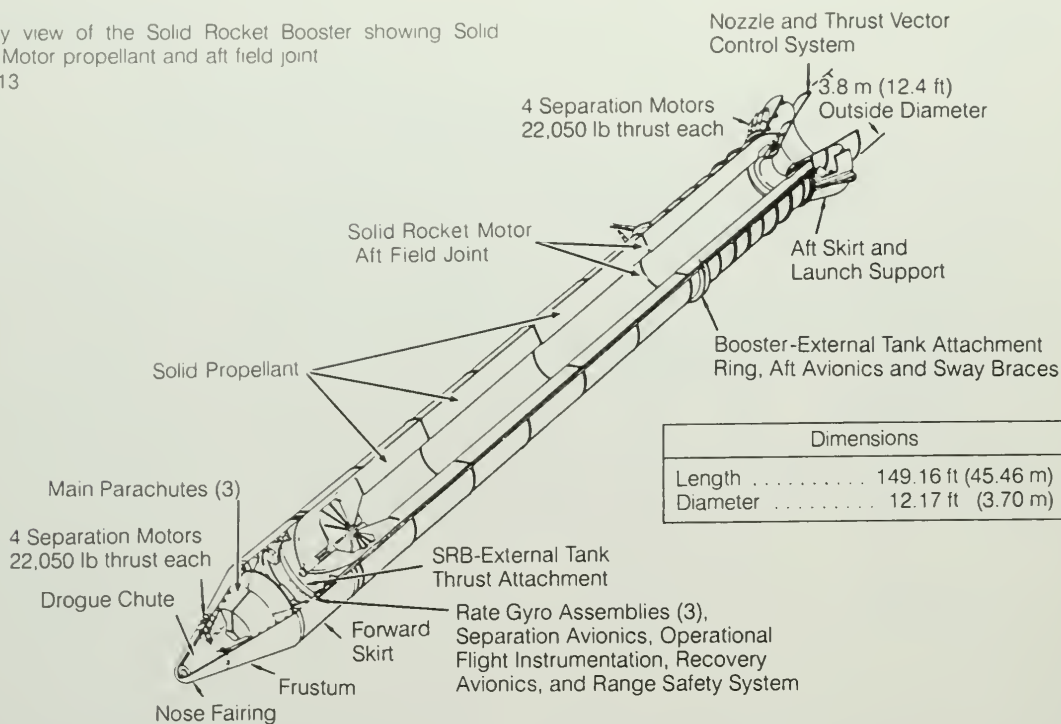
Cutaway view of the Solid Rocket Booster showing Solid Rocket Motor propellant and aft field joint  
Figure 13

During stacking operations at the launch site, four segments are assembled to form the Solid Rocket Motor. The resulting joints are referred to as field joints, located as depicted in Figures 8 and 13. Joint sealing is provided by two rubber O-rings with diameters of 0.280 inches (+0.005, -0.003), which are installed, as received from Morton Thiokol, during motor assembly. O-ring static compression during and after assembly is dictated by the width of the gap

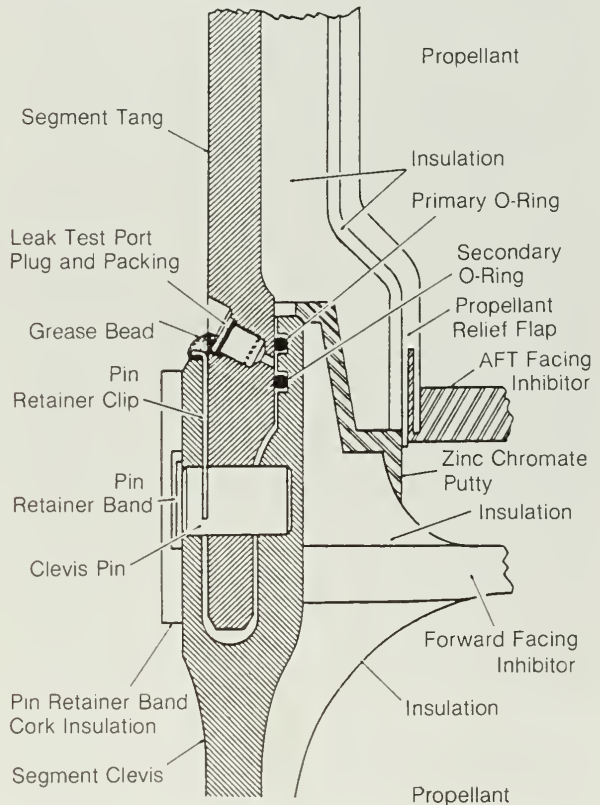
Figure 14  
Solid Rocket Motor cross section shows positions of tang, clevis and O-rings. Putty lines the joint on the side toward the propellant.

pressure loads are applied to the joint during ignition. Should pressure actuation be delayed to the extent that the gap has opened considerably, the possibility exists that the rocket's combustion gases will blow by the O-ring and damage or destroy the seals. The principal factor influencing the size of the gap opening is motor pressure; but, gap opening is also influenced by external loads and other joint dynamics. The investigation has shown that the joint sealing performance is sensitive to the following factors, either independently or in combination:

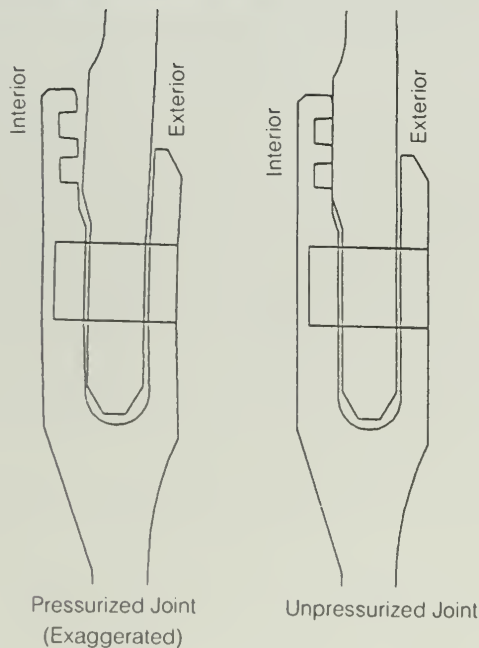
The gap to be sealed between the tang and the inside leg of the clevis opens as the combustion gas pressure rises. This gap opening was calculated as a function of pressure and time by an analysis that was calibrated to joint deflections measured on a structural test article. The analysis extended the results beyond test calibration conditions to include propellant effects and external loads. The initial static gap dimensions combined

Figure 16 Drawings show how tang/clevis joint deflects during pressurization to open gap at location of O-ring slots. Inside of motor case and propellant are to left in sketches.

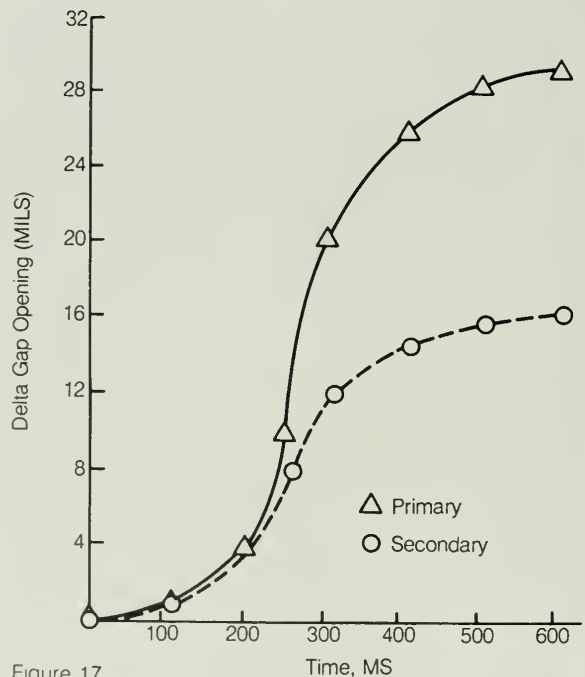
The joint deflection analysis established time histories for gap openings for primary and secondary O-rings for all field joints. For the aft field joints these data indicate gap opening increases of approximately 0.029 inches and 0.017 inches for the primary and secondary O-rings respectively. These values were used for sub-scale dynamic tests. Due to differences in motor pressure and loads, the gap opening increases for forward field joints are approximately 0.008 inches greater than for the aft field joints. Gap opening changes (called delta gap openings) versus time are shown in Figure 17 for the aft field joints. The total gap at any time also depends on the initial static gap, on rounding effects during segment pressurization, and on loadings due to struts and airloads. Sub-scale tests were run containing combinations of the above variables, but did not include the effects of the struts and airloads.

Figure 17 Graph plots changes in right booster's aft field joint primary and secondary gap openings. Horizontal scale is time in milliseconds from ignition.

Consistent results from numerous O-ring tests have shown a resiliency degradation with reduced temperatures. Figure 23 provides O-ring recovery from 0.040 inches of initial compression versus time. This shows how quickly an O-ring will move back towards its uncompressed shape at temperatures ranging from 10 to 75 degrees Fahrenheit. When these data are compared with the gap openings versus time from Figure 17, it can be seen that the O-rings will not track or
